EXISTING CONDITIONS REPORT

PHASE I OF DESIGN FEASIBILITY STUDY FOR IMPROVEMENTS AT THE

MIACOMET GOLF CLUBHOUSE

PREPARED FOR THE
NANTUCKET ISLANDS LAND BANK
22 BROAD STREET - NANTUCKET, MA
FEBRUARY 8TH, 2016

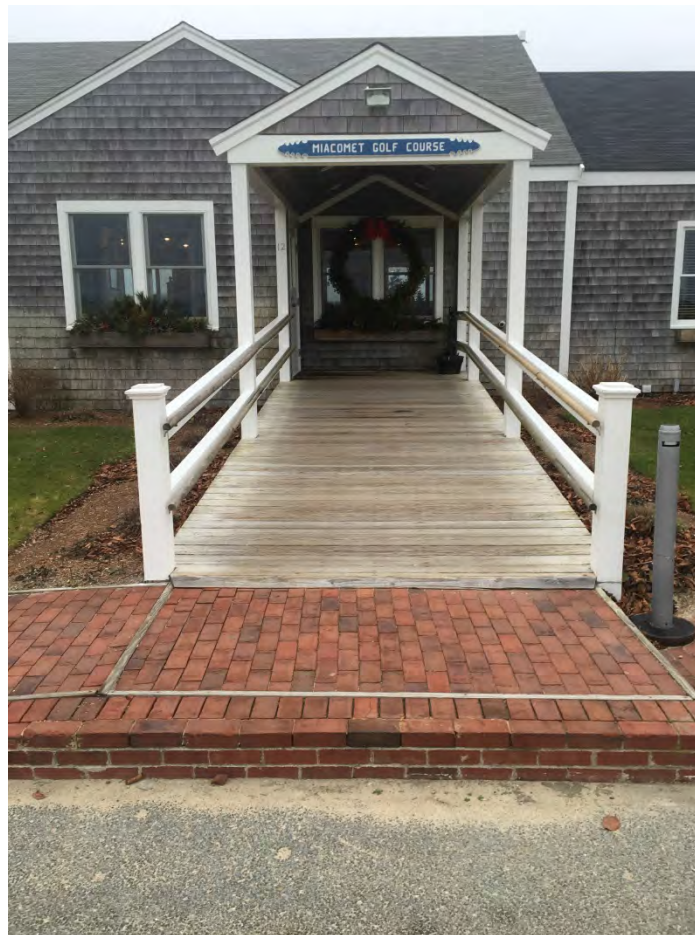
Front drop-off & entry ramp:

Landing at base of ramp down to roadway is built with brick which could be dangerous if it comes loose. It should not end abruptly at a step. Should be replaced with concrete or stone curb with durable walkway surface. Must have accessible curb cut. Ramp to entry door appears to be acceptable slope, but is in fact wider than allowed between rails.

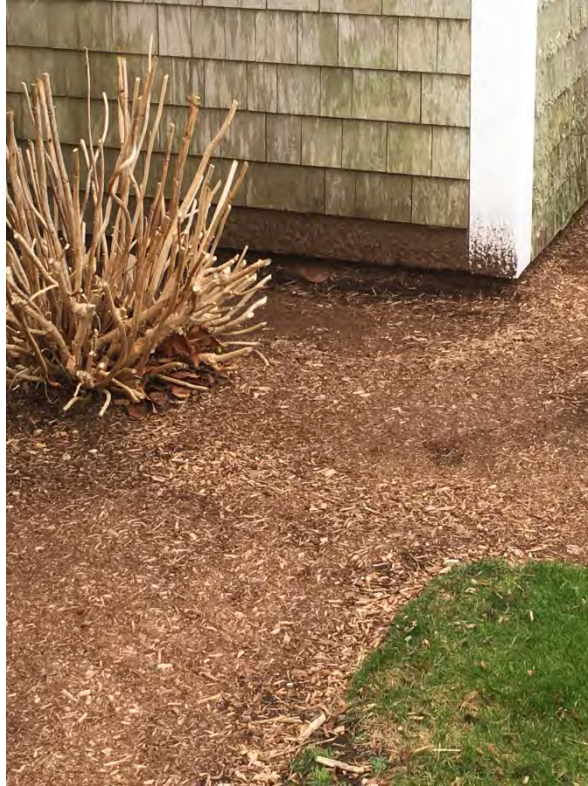
Grade is too high at perimeter of the building, does not meet code, and must have 8" separation to grade.

Mulch and mud splashing up on building; which promotes rotting deterioration of the cedar siding.

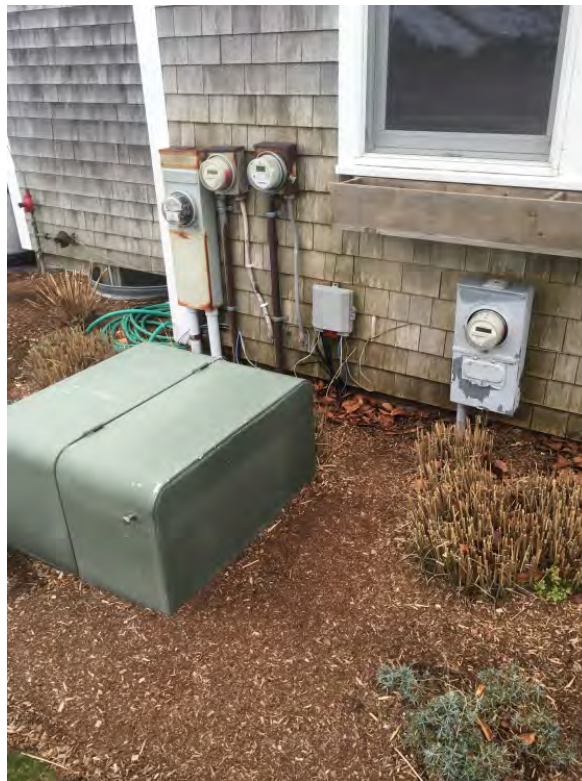
Electric Service or Services are very confusing (see electrical report as well)

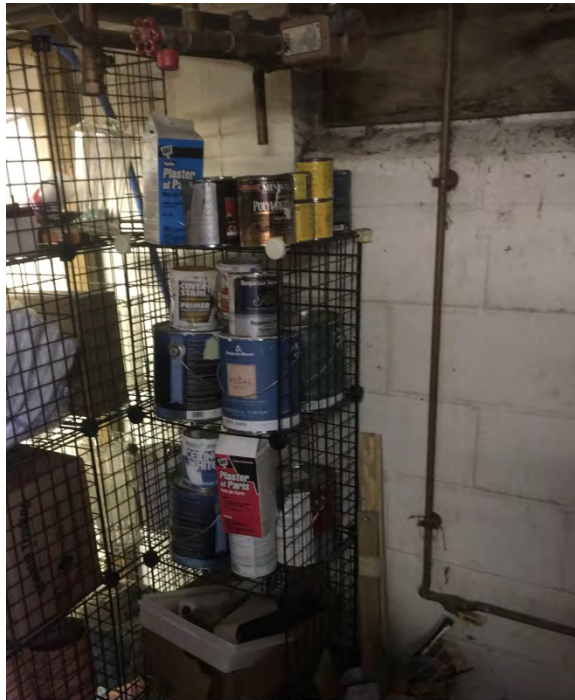
Storage in the basement is tucked in everywhere it can be and some places it should not be. Wire partitions and shelves leave material open to mechanical equipment, etc. New dedicated storage spaces for liquor, tableware, linens, etc. will need to be included in the future project.

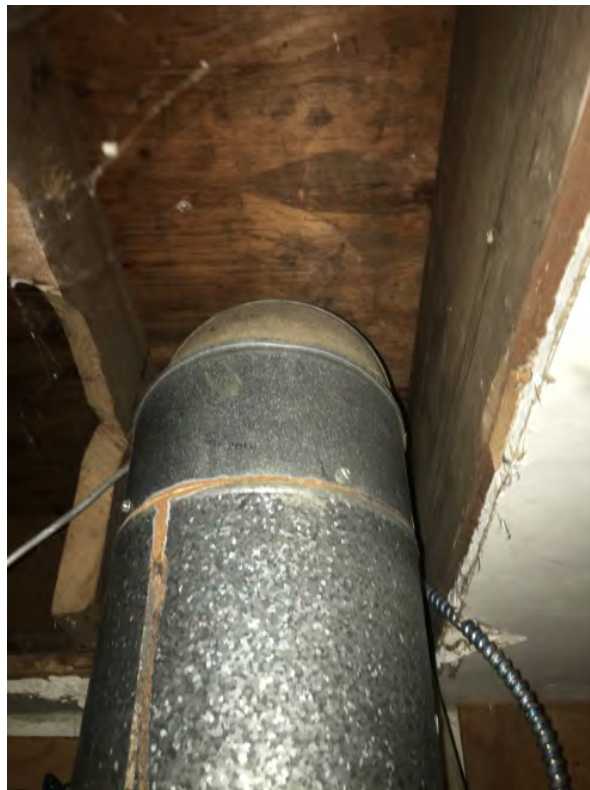
Boiler flue pipe is passing through floor frame. Must review clearance to combustibles.

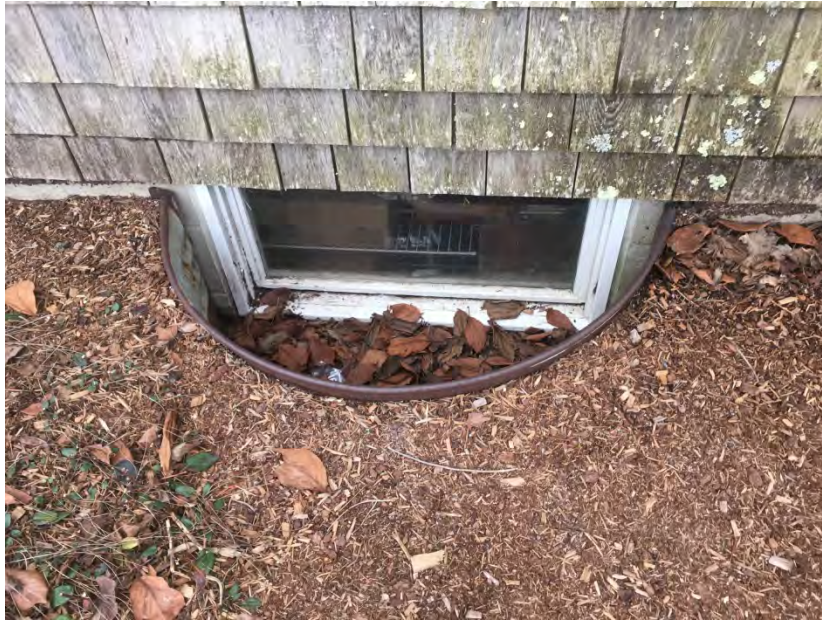
Basement window well nearly below grade. This window has flooded in the past filling the basement with water.

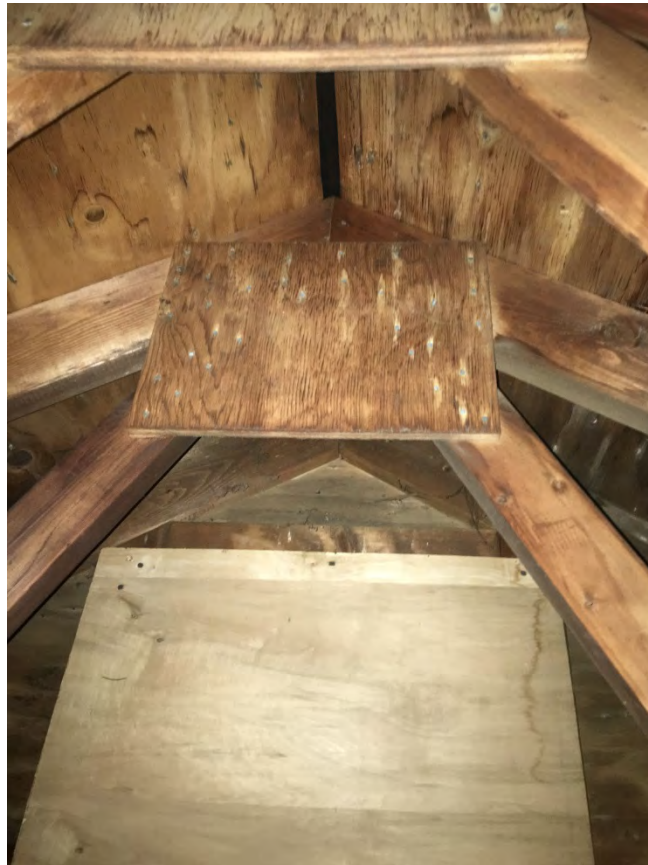
Attic of Building #1 the Old Clubhouse.

The roof framing consists of field fabricated roof trusses, the individual members of the trusses are sound but these trusses will not meet today's codes. One truss has been compromised. See structural report as well.

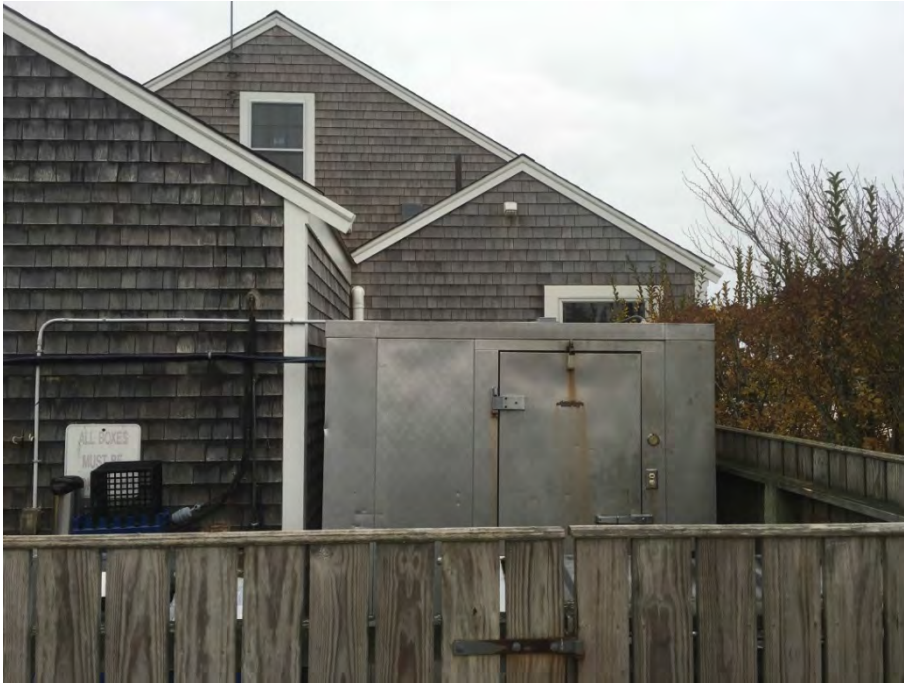
Yard enclosing walk-in cooler and trash receptacles are in the front/side yard; most golfers travelling the course and the parking area have to pass by this service area. At times this area may also be very busy with service and delivery vehicles mixing with cars and pedestrians.

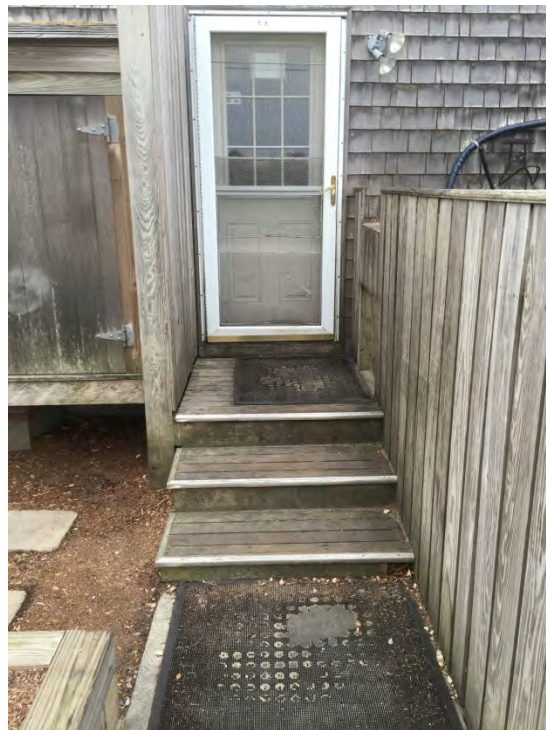
Staff entry to rear of kitchen is difficult to navigate for deliveries.

It is narrow and has multiple uneven steps.

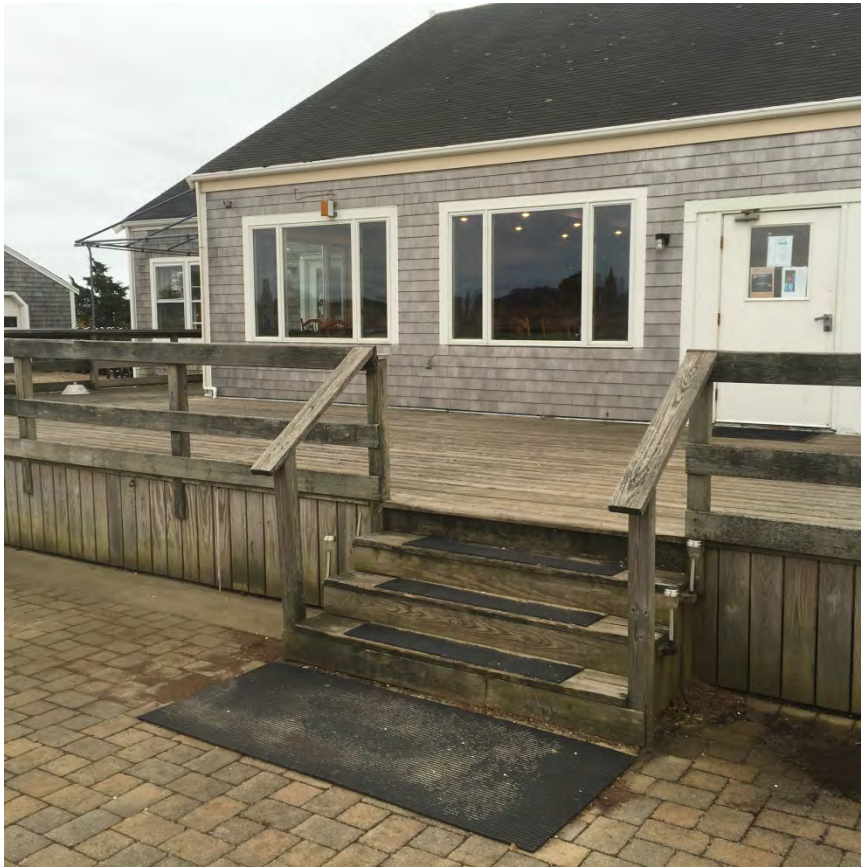
Rear deck is a favorite place for diners. The roof awning canopy and frame were forcefully removed by wind and destroyed.

The access to the deck is not accessible from grade. A handicapped guest must use the front door.

Railings are not compliant with current codes.

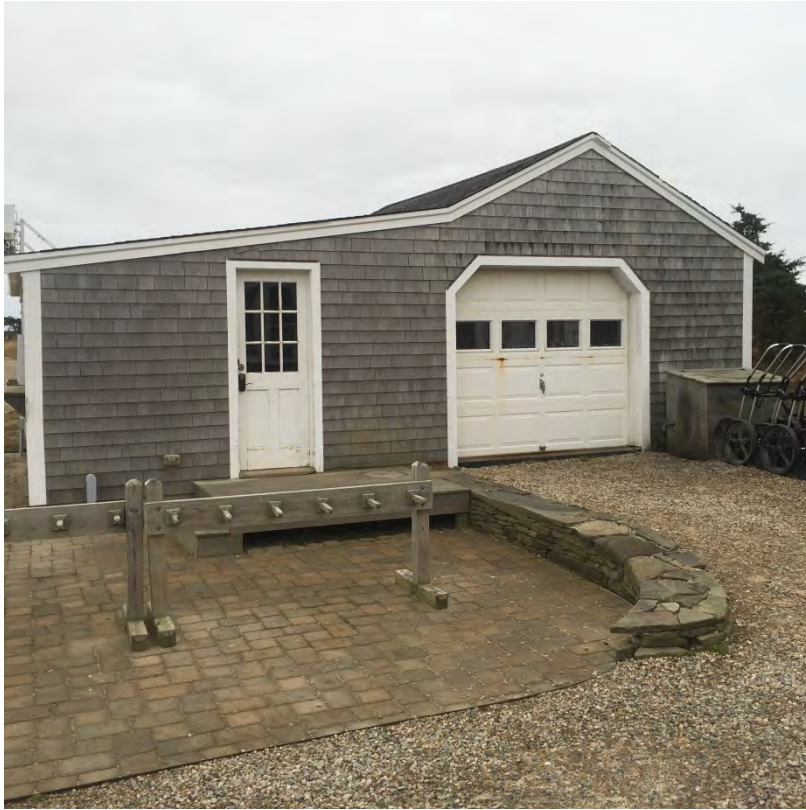
Building #3

The “Starters Shed” is in good condition and may need just some repairs to make the appearance match the ultimate design scheme.

Other improvements that should be made to make this building accessible as well.
