# **MIACOMET GOLF CLUB**

## **MECHANICAL, ELECTRICAL, PLUMBING, AND FIRE PROTECTION EXISTING CONDITIONS SURVEY**

**ISSUED BY: CONSULTING ENGINEERING SERVICES  
128 CARNEGIE ROW SUITE 204  
NORWOOD, MASS. 02062**

**ISSUE DATE: 2/8/16**

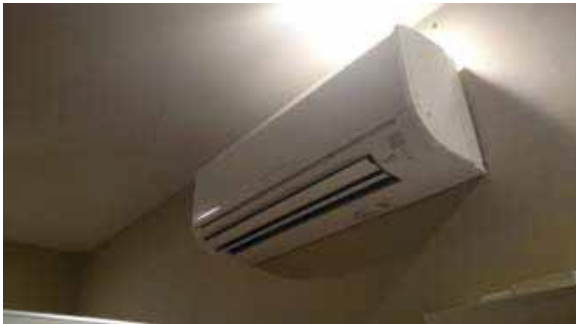
The club house has no air conditioning for any parts of the facility except for the women's toilet room. The women's toilet is equipped with a wall mounted split system cooling/heat pump unit. The unit has a capacity of 9,000 btu/hr. This unit is set outside the building in an area that presents a very difficult service opportunity. The site is also enclosed to a point that the availability of air for condensing unit heat rejection is not in good design practice. The lack of air conditioning has proven to be a comfort problem in the summer months when restaurant activity is at its highest.

**MI.1 - Air Conditioning in Womens Toilet**

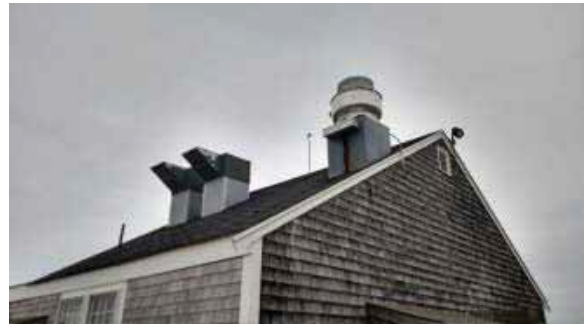
A major problem with the operation of the clubhouse as a dining venue is the ventilation of the kitchen. An inspection of the kitchen hood intake and ventilation system shows that there is no heated make up air stream. We are told that because of this, the supply air fans used to provide make up air for the kitchen hood are shut off on cold days. This is due to the "cooling off" it does to the hot food waiting to be served, as well as creating a very uncomfortable work environment. The hood exhaust system is not up to what is considered good design practice. The dishwasher is not vented and it is presumed that this unit displaces the steam condensate into the kitchen.

The main problem this causes is the intake of air from the adjacent space to act as make up air for the hood exhaust. Where that air comes from in turn, is from the outdoors. The replacement air is pulled into the kitchen from the dining area which is drawn into the building from the outdoors,

**MI.2 -Fresh Air Intake and Exhaust for Hood**

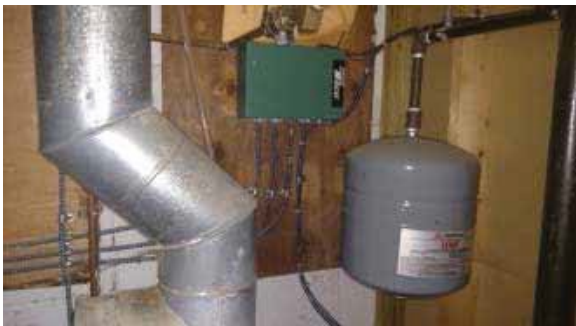
The boiler is located in the basement area of the building behind a door that is not fire rated. The "room" that housed the boiler, once you are past the door, is in actuality the remainder of the basement. In other words there is no boiler room for the boiler. The boiler vent is a single wall sheet metal connector and flue that is directed to the outdoors. This flue is equipped with a power exhaust that extracts flue gasses from the boiler and discharges them outdoors. This fan is mounted on the outside wall near the ground. The flue near the connection point to the fan shows severe rust and a high degree of deterioration. The location of the fan near the ground appears to allow melted snow to re-enter the fan housing. This water, when mixed with the acid fumes of the flue gas is the likely cause of the damage. This issue should be considered serious as it may be allowing combustion gases into the building. The location of the combustion relief fan is also too close to an operable window outside and this is a code violation.

**MI.3 - Flue From Boiler**

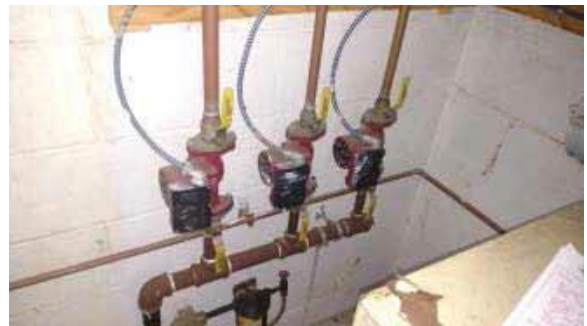
An inspection of the hot water piping system reveals that there are a total of three (3) heating zones that serve the space. There are three zone circulator pumps that start and stop as commanded by a wall thermostat. All of the existing piping that is installed in the basement as well

**MI.4 - Zone Pumps**

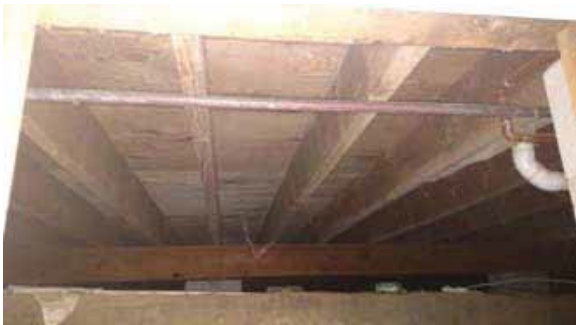
as the crawl space under the building is uninsulated. The look of the piping also indicates that there have been extensions from the main lines over the years that were made as a result of cold spots being addressed. The piping is insufficiently supported and the supports are poorly installed. At one area adjacent to the fuel oil tank, there is a water line installed directly over an electric panel which is a code violation.

**MI.5 - Uninsulated Piping in Crawl Space**

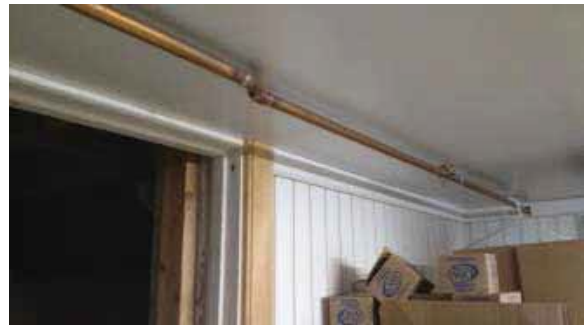
**MI.6 - Uninsulated Supply Piping**

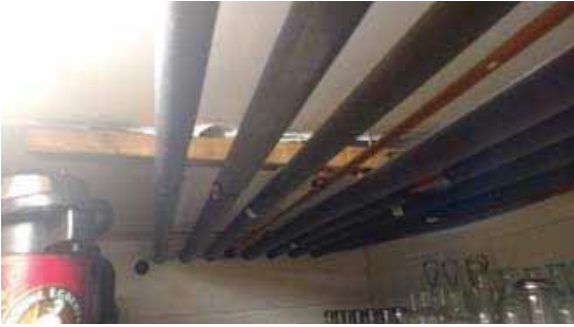
**MI.7 – Poorly Hung Piping in Basement**

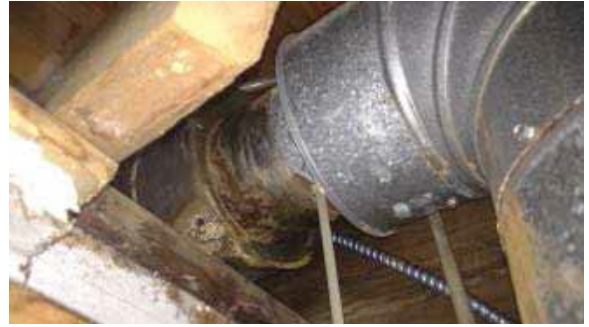
**MI.8 – Corroded Boiler Flue**

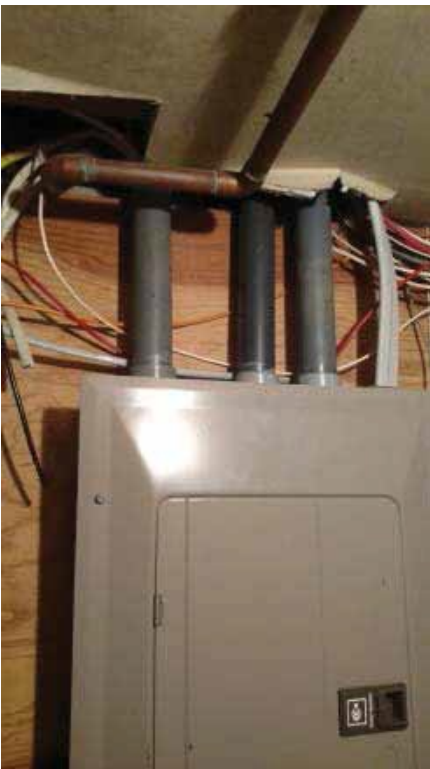
**MI.9 – Water Piping Above Electrical Panel**

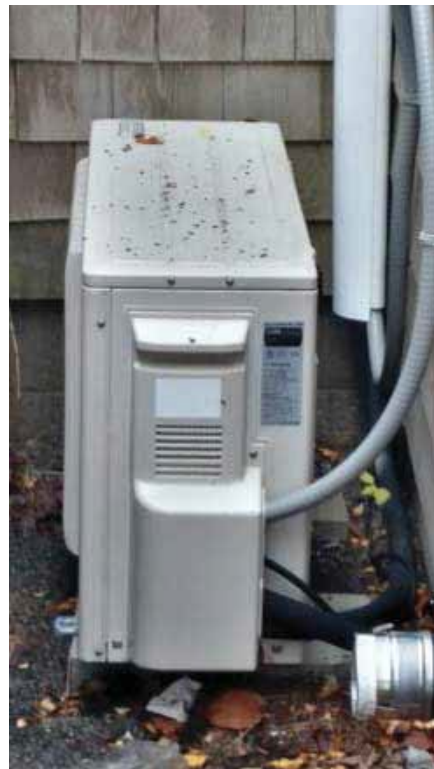
**MI.10 – Condensing Unit & Water Heater Flue**

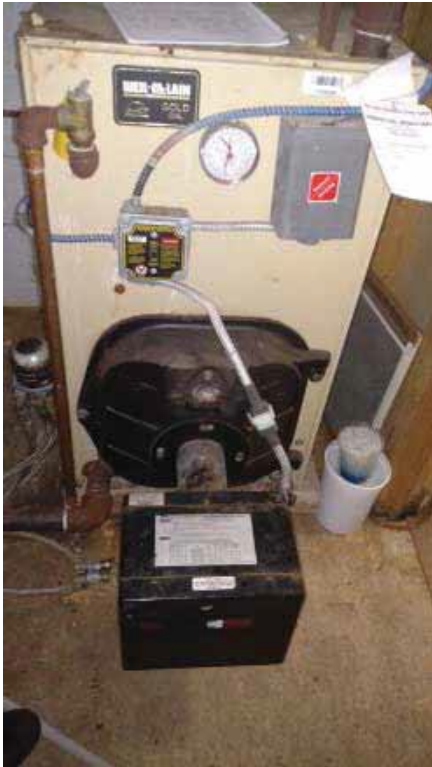
The boiler itself is in fair to good condition with a current tag showing a recent cleaning. There are also no leaks evident at the body of the boiler or at the base. Another issue at the boiler is the area surrounding it. This area is packed with combustible stored materials such as paints and stains. This area is not conducive to good maintenance of the boiler and the associated piping systems. The boiler is fed from a 275 gallon storage tank in the basement. The tank is in good condition. It is vented to the out of doors. The tank is fitted with a firematic valve, and shut off valve. The tank does not have a containment dike around the base to contain any leakage or spill.

**MI.11 – Cast Iron Water Boiler**

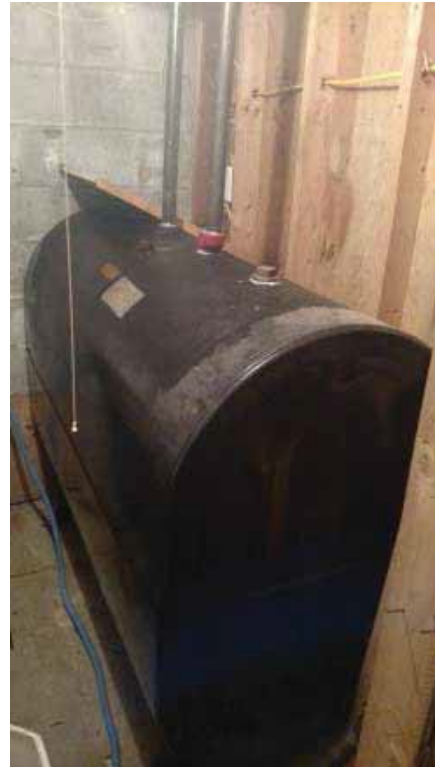
**MI.12 – Fuel Oil Tank**

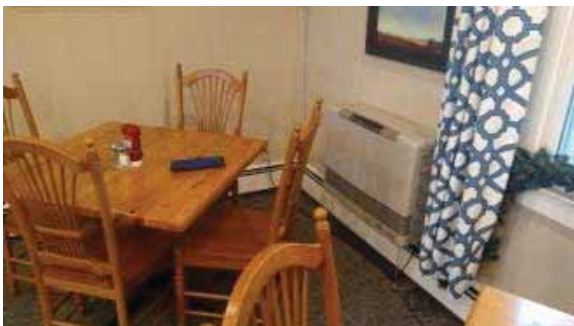
**MI.13 – Direct Fired Propane Heater**

The existing radiation at the perimeter of the walls would be removed in the main rooms. Some radiation such as in the toilets may be retained depending on the design. It would be our recommendation to remove the direct fired propane heater installed in the Dining Room and reinstall it into the entry Vestibule.

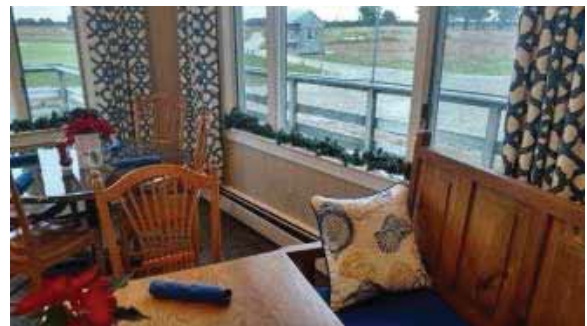
The existing baseboard heaters serving the spaces generally run from wall to wall with finned tube inside the enclosure. If the entire enclosure was equipped with finned radiation, which is never the case, the length of active element would be at most, approximately 150 feet. That would mean that to release 126,000 btu/hr of heat, the element would need a capacity of 840 btu per foot. The usual capacity for residential heating element of this style is approximately 600 to 650 btu per foot. This is a clear indication that the element that is installed is not enough to distribute the required heat.

**MI.14 – Typical Baseboard Heater**

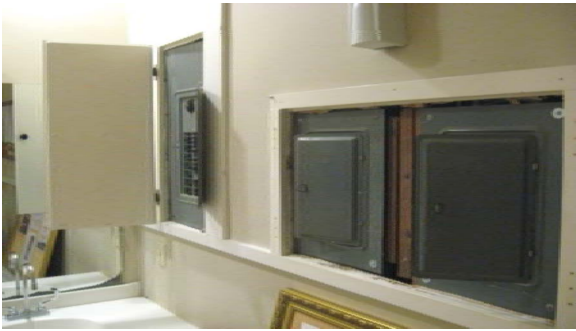
PP-1 and PP-2 are mounted adjacent to MDP-1. Both panels have a 100A 2-pole Main Circuit Breaker. There is no identification if these panels are directly fed from MDP-1 or if there is a dedicated feed from the transformer located in front of the building. Both panels have calcium buildup on breakers. The panel schedules for both panels have been edited several times and they have become unreadable.

**El.1 - Panels located in Women's Bathroom**

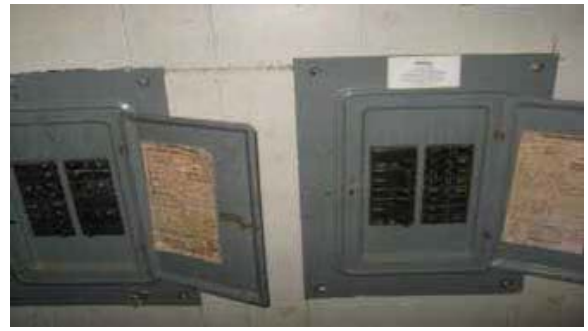
According to the panel schedule, existing panel MDP-1 has a single 40A double pole breaker for the Kitchen Sub Panels. PP-3 and PP-4 are both main lug panels as they do not have a local disconnect except for the breaker in MDP-1. It is unknown if PP-3 and PP-4 are both fed from the same 40A breaker in MDP-1.

**El.2 - Kitchen Electrical Panels**

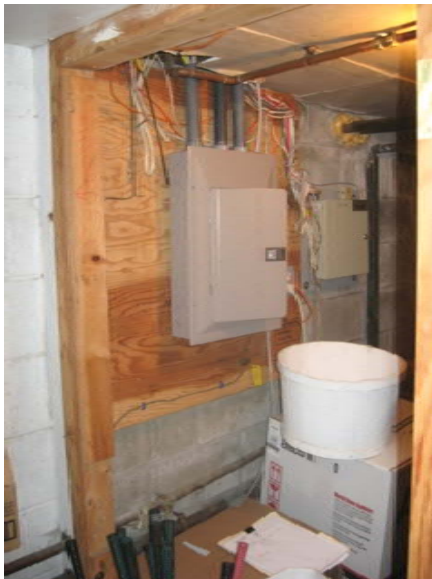
**El.3 - Panel with water pipe routed above**

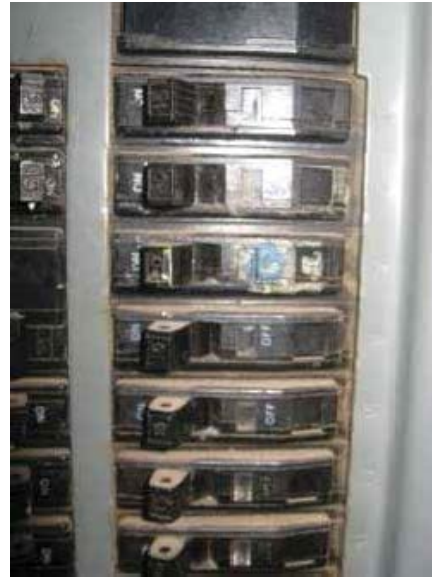
Code violations are apparent throughout the Club house: There appears to be multiple services to the main building, services running through other buildings, and disconnects missing from panelboards. The panelboard breakers are becoming corroded and the panel board casing is rusty. Additionally, the utility meters are rusted. Furthermore, there is no service disconnect for the

**El.4 - Corroded Circuit Breakers**

The existing Electrical distribution system of the clubhouse needs to be upgraded. Due to the age of the panel boards, it is likely that there will be a critical failure of infrastructure. A new distribution system will allow for a single main distribution board to service the property. Currently, there is no main distribution panel or switchgear with all loads attached to it. Given that space is a luxury at this location, it is highly recommended that space is created for a dedicated electrical room to house a main switchgear for the complex.

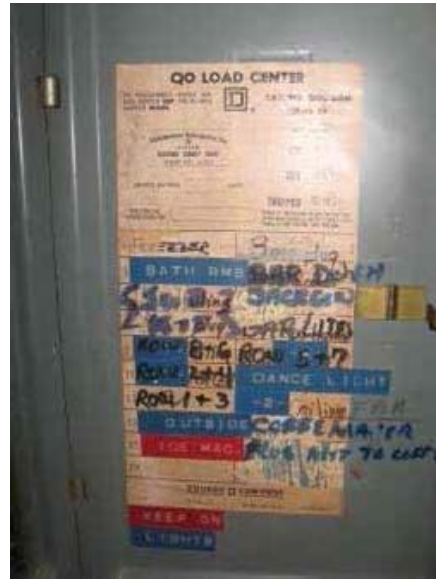
**EI.6 – Poorly Maintained Panel Schedule**

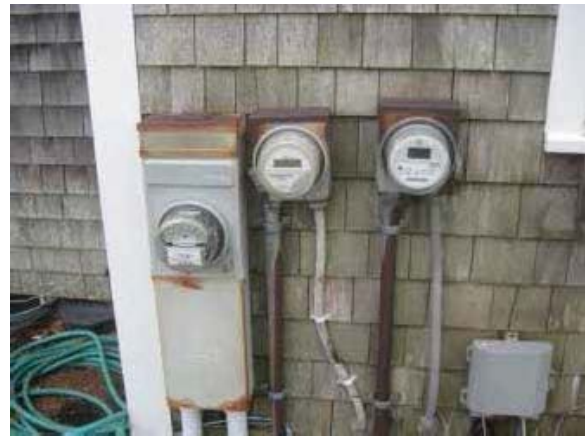
**EI.8 – Poorly Maintained Utility Meters**

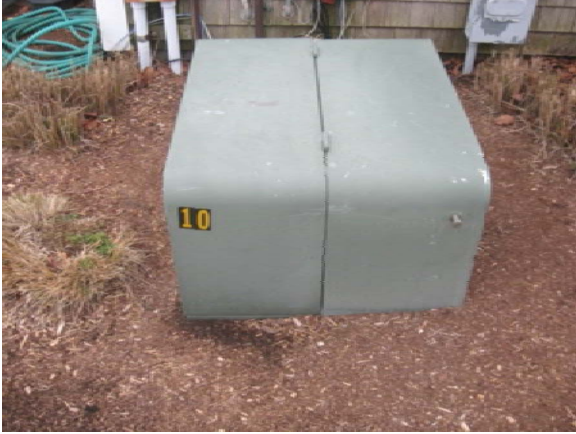
This space is served by a dedicated 240/120 volt, 1-phase, 200 amp service (photo). The electrical service is fed underground from a 50KVA transformer located in front of the Club House. Several electrical meters are located on the outside wall of the Club House. Upon further investigation with personnel from National Grid, the transformer was found to be rated for 50KVA. During the peak months of April through November however, the transformer sees a peak demand of over 100KVA. These values represent an overloading of the transformer.

**El.9 - Club House Transformer**

Additionally, the transformer and main service is at critical capacity and it is recommended that it be upgraded to satisfy the demand of the entire property.

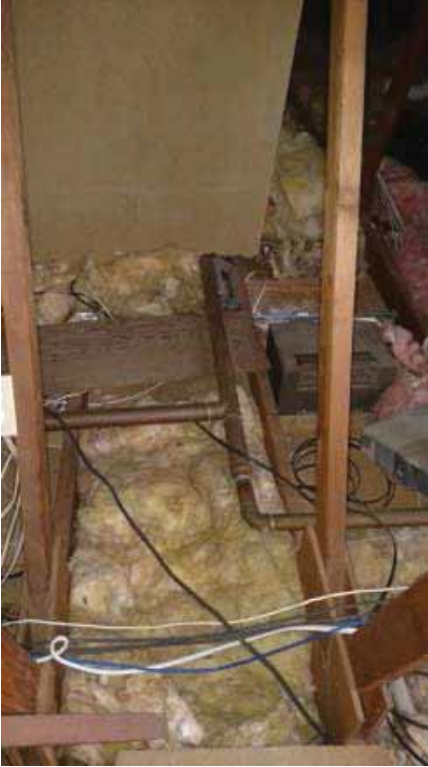
**PI.14 – Plumbing Vent piping in Attic**

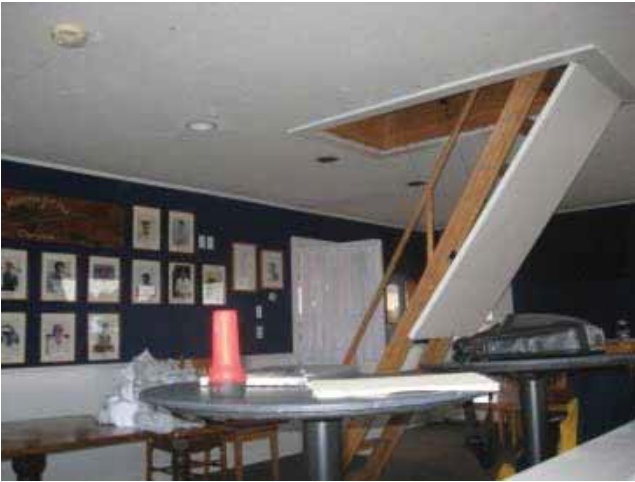
**FI.5 – Smoke Detector in Function Room**

Although a Fire Alarm system is not required, it is recommended that an addressable Fire Alarm Control Panel and devices are installed throughout the clubhouse. The addressable system will allow for higher accuracy for emergency personnel in the case of fire. The location of the Fire Alarm Control panel shall be in the main Entry Vestibule to insure that Fire Fighters have easy access to the panel. It is recommended that the exit placards be replaced with Red or Green LED lights. This will be similar to existing conditions in the Administration building.

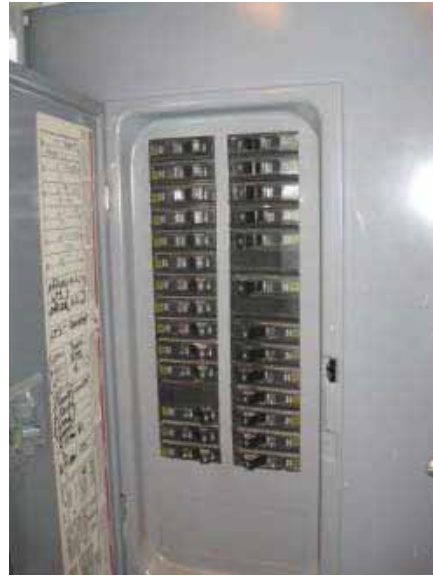
**If PP-6 is fed directly from the transformer, that would mean there are two utility services entering this building. Two services entering a building is typically a code violation; nor is it good engineering practice. Upgrading to a single service of proper size will alleviate this problem.**

E2.2 - Panel PP-6 in Pro Shop

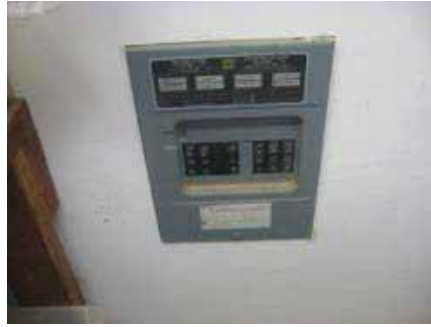
There is a single panel located in the building, referred to in this study as PP-7. The panel is fed directly from panel PP-5 in the Clubhouse. PP-7 is a single phase panel with no main circuit breaker. PP-7 also feeds the snack bar located up the road from this building. It was noted that this panel is not sized properly as it is prone to tripping.

**E3.2 - Local Panel**

It is recommended that a dedicated service feed from the recommended switchgear be used to power the Golf Club Storage area. Also, upgrade to a bigger service size to prevent tripping of the breakers.
