EXISTING CONDITIONS REPORT

PHASE I OF DESIGN FEASIBILITY STUDY FOR IMPROVEMENTS AT THE

MIACOMET GOLF CLUBHOUSE

PREPARED FOR THE
NANTUCKET ISLANDS LAND BANK
22 BROAD STREET - NANTUCKET, MA
FEBRUARY 8TH, 2016

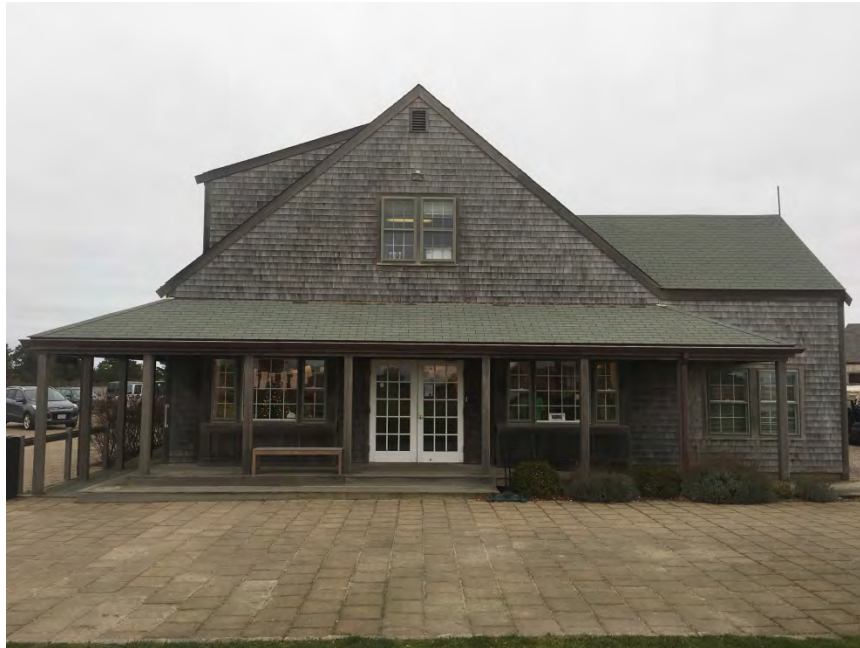
Building #2 – Entry to Pro Shop / Club Managers Office above

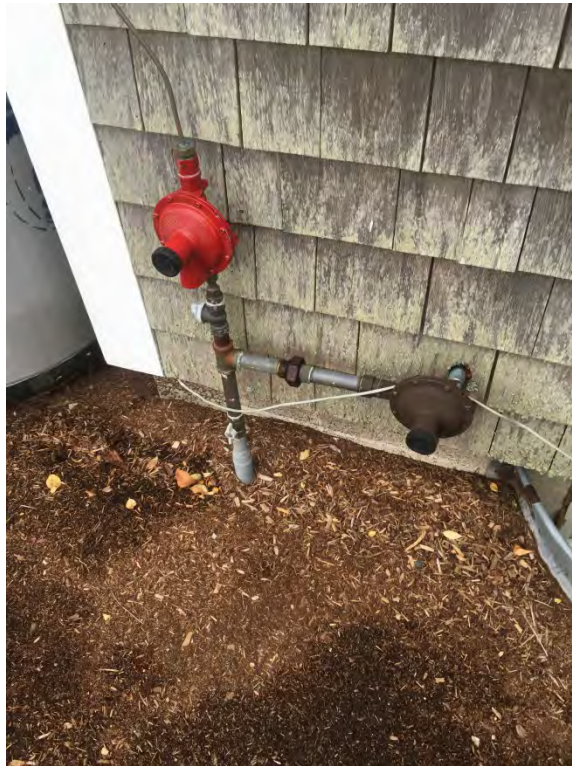
Propane Gas Service entry.

Underground tank in yard typically serves the building.

At time when the tank is empty or being serviced the above ground cylinder can serve the building.

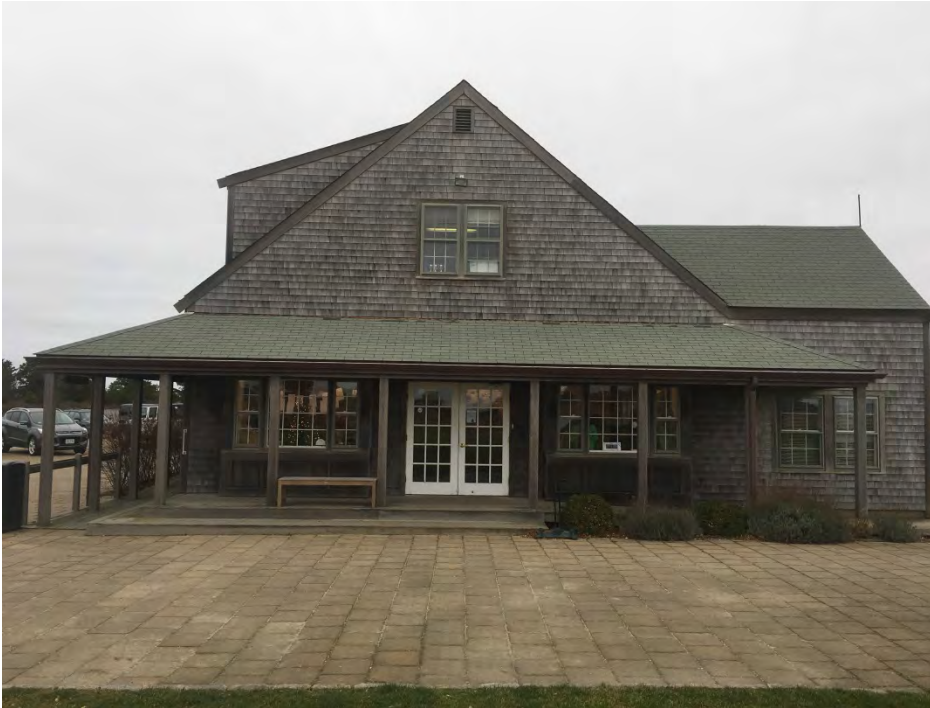
*Building #2
This building was once the old maintenance facility was renovated into the pro shop and offices.
A portion of the first floor is storage for the clubhouse operations.
Red cedar shingles and trim has weathered to dark even patina.
The wrap around porch is also a nice feature.*

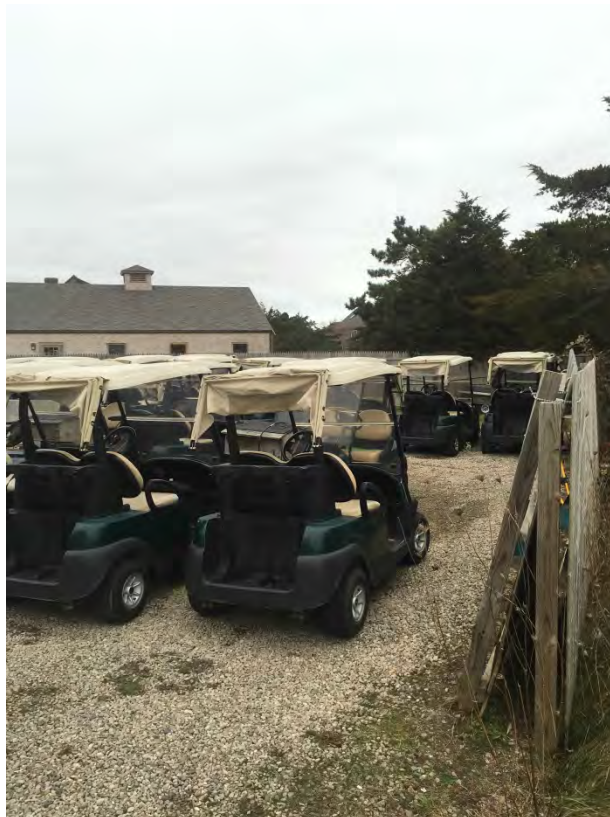
Exterior Golf cart Storage is moving into the newly constructed barn in the distance.

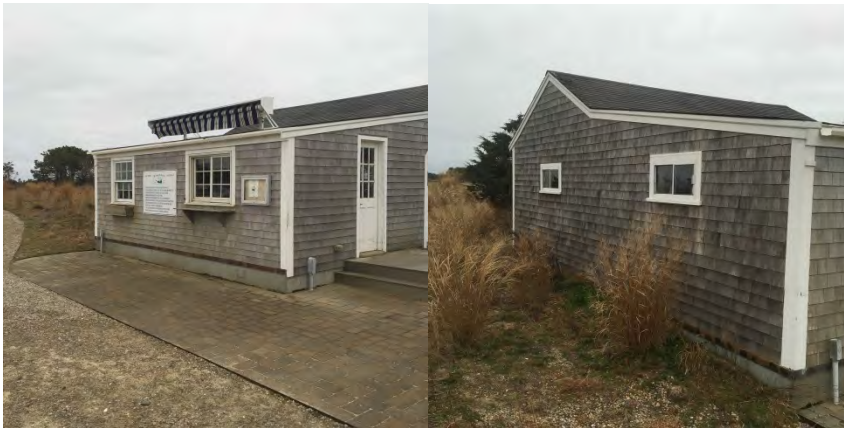
These photos show the “hard-scaping” materials which include concrete paves and native stone pathways which are appropriate for the setting.

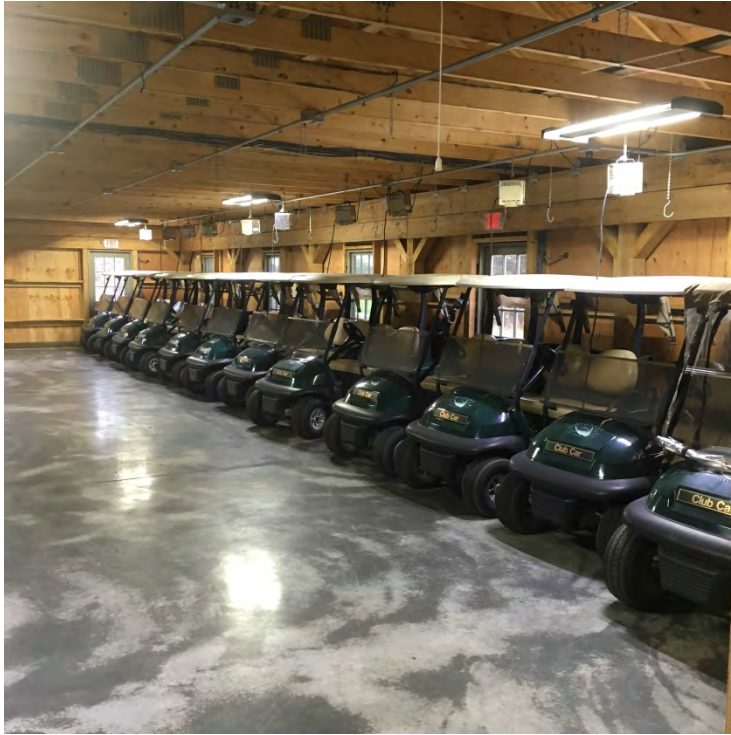
Building #4

*New Golf Cart
Storage Barn.
This photo shows
interior of post and
beam frame
structure with
pendant mounted
lighting and electric
cart chargers
hanging from the
roof trusses.*
